The
Indiana
Historical
Radio Society

June 2009

Restoring a Philco 38-116

Jeremy Schotter

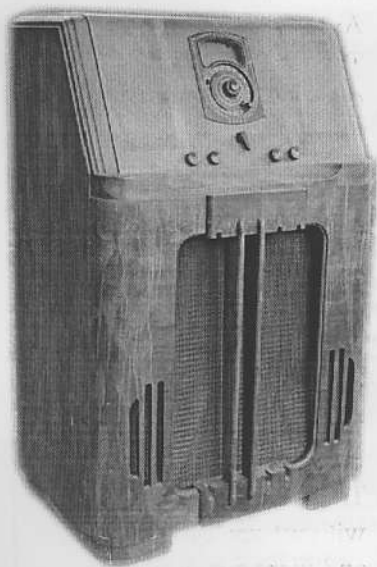
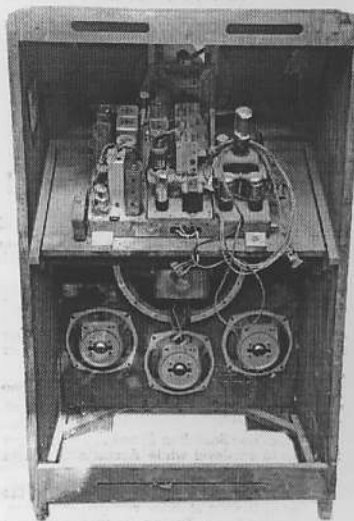
The cabinet and chassis prior to restoration in August 2008

No project is more intimidating than a 15 tube chassis that has been hacked up by a previous repairman. Perhaps that is why I put off restoring this radio for almost three years. My first task was to begin tracking down missing or damaged parts. Original replacement parts that had to be found included:

- 5 Tube Shield Bases, someone had hacked up the originals to accept metal or GT style tubes.
- 4 New filter cans and mounting brackets to restuff, the originals were completely removed.
- A five pin plug and socket for the speaker, these had been replaced with a Molex type plug and socket.
- Several tube shields, these were missing.
- A complete set of G style tubes, just wanted the chassis to look good and original after restoration.
- 2 new tube grid caps, two were replaced with some big gawdy black plastic ones.
- A new dial scale, the one with my chassis had been broken and I would later find out was the wrong one entirely.

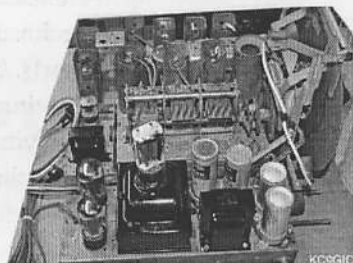
The restored chassis.

At this point the radio was working extremely well despite its history of rough repairs. Apparently the only thing someone hadn't messed with in the past were the trimmer capacitors, as no alignment was needed. At this point it was time to get the chassis looking better cosmetically. Some NOS tube shield bases were acquired to replace those that had been hacked up. The rivets holding down the originals had to be drilled out, and flathead 6-32 screws and nuts were used to bolt in the replacements. The black paint on the transformers was chipped up, so a new coat of black lacquer was sprayed on to spruce them up a bit. Finally using a Dremel and a wire brush the entire chassis was lightly cleaned, using Brasso on some parts. The final results don't look too bad for a seventy year old piece of metal.

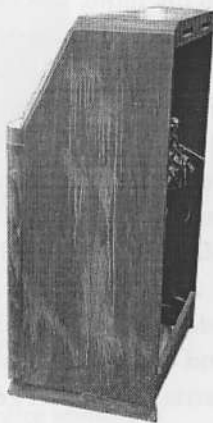
The cabinet had been stripped in the past, a sloppy job though. A liquid had been splashed on the sides and top, resulting in big bleached looking spots. My largest concern was if these spots could be removed or covered up. Washing and scrubbing with different chemicals had no effect. Some orange Citistrip was brushed on over the spots, and was allowed to soak in for half an hour or so. Once the stripper was removed, and the cabinet was washed down, the spots seemed to be completely gone. Photo to the right shows the cabinet before being cleaned up showing the spots.

The other obstacle was replacing the two missing vertical bars in front of the speaker grille. A close family friend who restores antique furniture knew of an Amish woodworker who could reproduce about any obscure part as long as he had a pattern to go by. So they took one of the remaining bars to him, and a few weeks later I had two perfect reproductions. As for a price, the woodworker wouldn't accept more than \$10 for the job. All of the bars were sanded and the grain was filled. They were then toned with Mohawk extra dark walnut and then medium brown walnut so that they would match.

The bars were then reglued to the cabinet. With no other repairs needed, it was time to refinish the cabinet. The whole cabinet was sanded prior to refinishing, and any dust was blown away with an air compressor followed by wiping down with a tack cloth. Deft brand gloss lacquer was used, sprayed on with a Critter spray gun. The lacquer was thinned down, using three parts lacquer and one part thinner. After several coats of lacquer, the decals were ready to be installed. All of the decals needed for this model were purchased from [RadioDaze](#). These decals were a royal PITA to apply! There is a word in the shape of an arc over each knob that designates the function of that particular control. These were very hard to match up and keep a consistent distance between them all. Applying these was a tedious process, but the final result turned out pretty good. Once the decals had dried, a layer of clear lacquer was sprayed over them.
